# ESP32-C6

Series SoC Errata Version 1.1

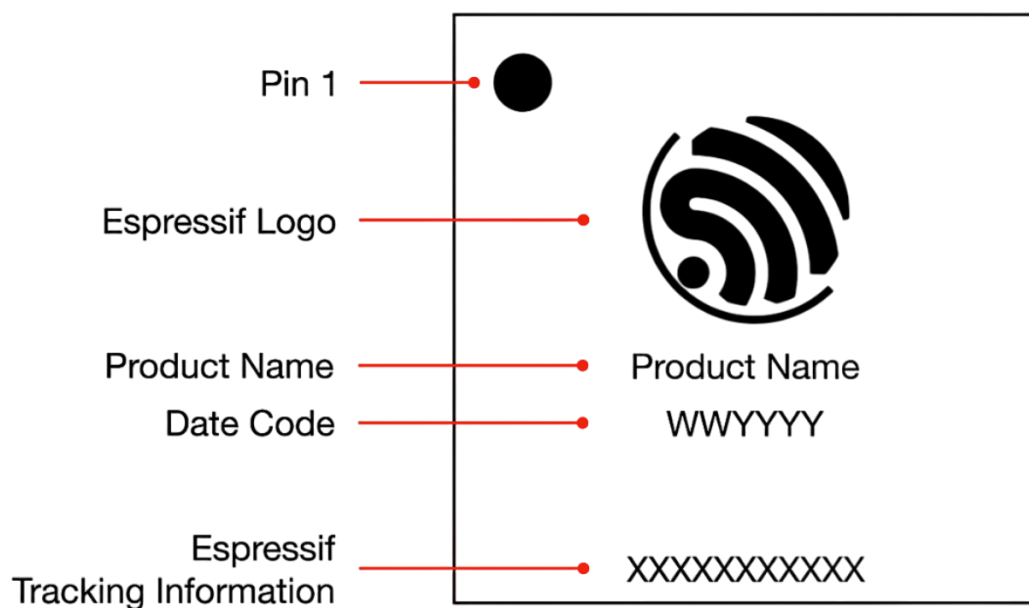
Figure 1.1: Chip Marking Diagram

- **Espressif Tracking Information** line in chip marking

Table 1.2: Chip Revision Identification by Chip Marking

Chip Revision	Espressif Tracking Information
v0.0	X A XXXXXXXXXX
v0.1	X B XXXXXXXXXX
v0.2	X C XXXXXXXXXX

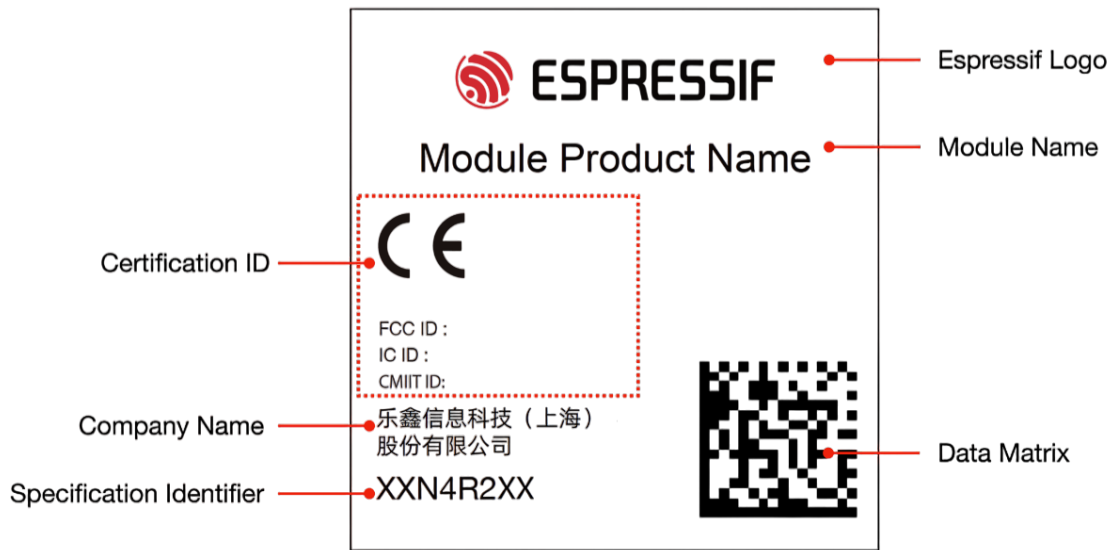
Figure 1.2: Module Marking Diagram

- **Specification Identifier** line in module marking

Table 1.3: Chip Revision Identification by Module Marking
