ESP32-C6

Series SoC Errata Version 1.1

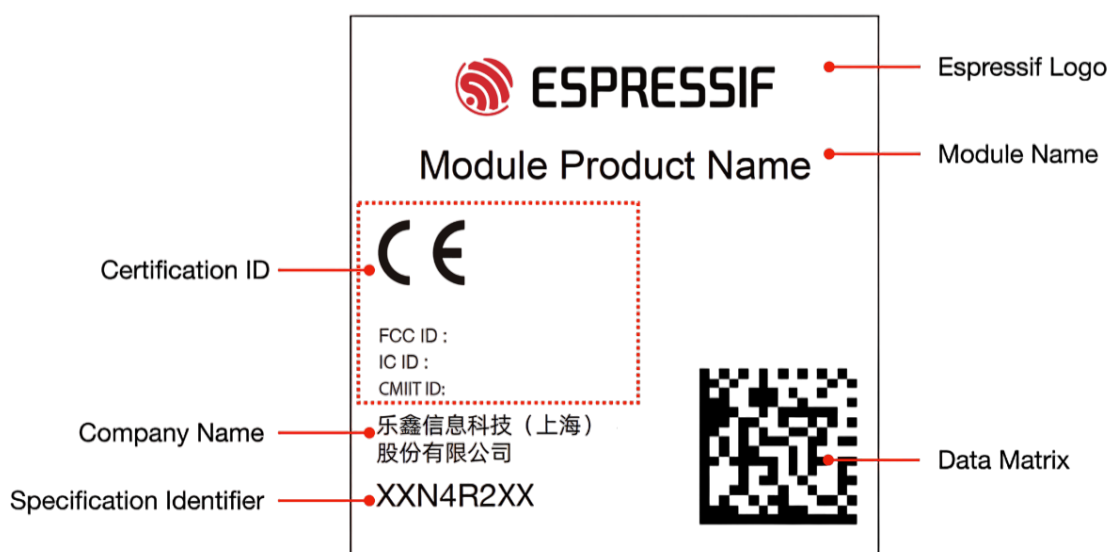
Figure 1.2: Module Marking Diagram

- **Specification Identifier** line in module marking

Table 1.3: Chip Revision Identification by Module Marking
