# ESP32-S2

Series SoC Errata Version 1.2

# 1 Chip Revision Identification

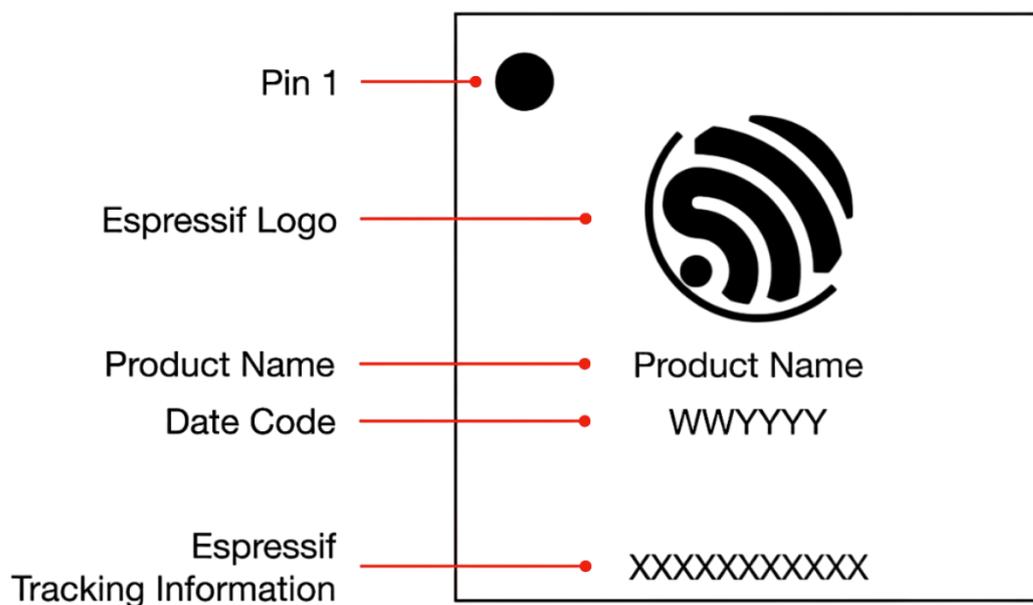
Figure 1.1: Chip Marking Diagram

- **Espressif Tracking Information** line in chip marking

Table 1.2: Chip Revision Identification by Chip Marking

Chip Revision	Espressif Tracking Information
v0.0	X A XXXXXXXXX
v1.0	X B XXXXXXXXX

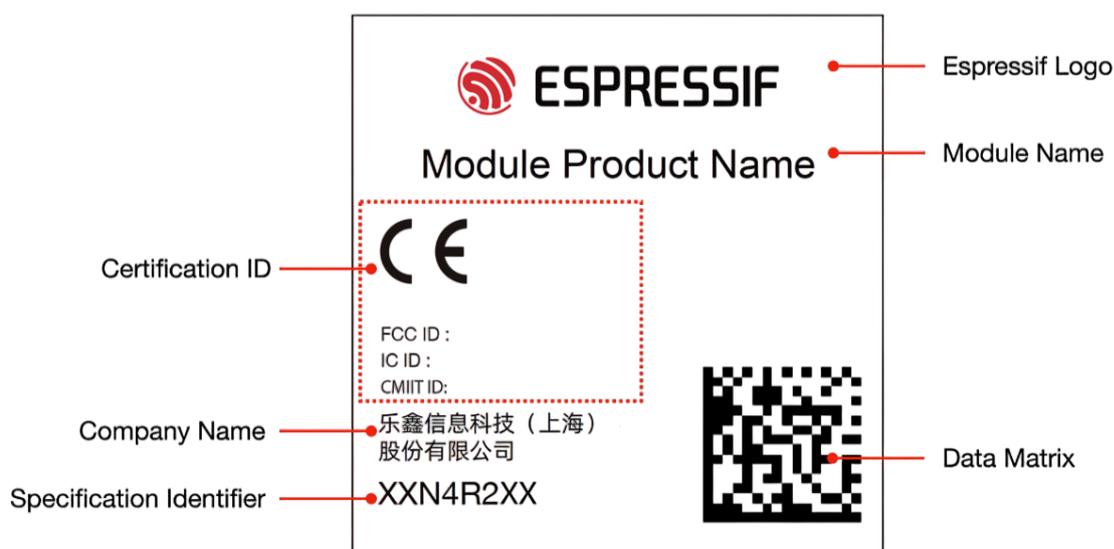
Figure 1.2: Module Marking Diagram

- **Specification Identifier** line in module marking

Table 1.3: Chip Revision Identification by Module Marking
